PHASE I ENVIRONMENTAL SITE ASSESSMENT REPORT

**3.3-ACRE ECKENRODE PROPERTY
WARWICK TOWNSHIP, TUSCARAWAS COUNTY, OHIO**

**CIVIL & ENVIRONMENTAL CONSULTANTS, INC.
COLUMBUS, OHIO**

CEC Project 132-755

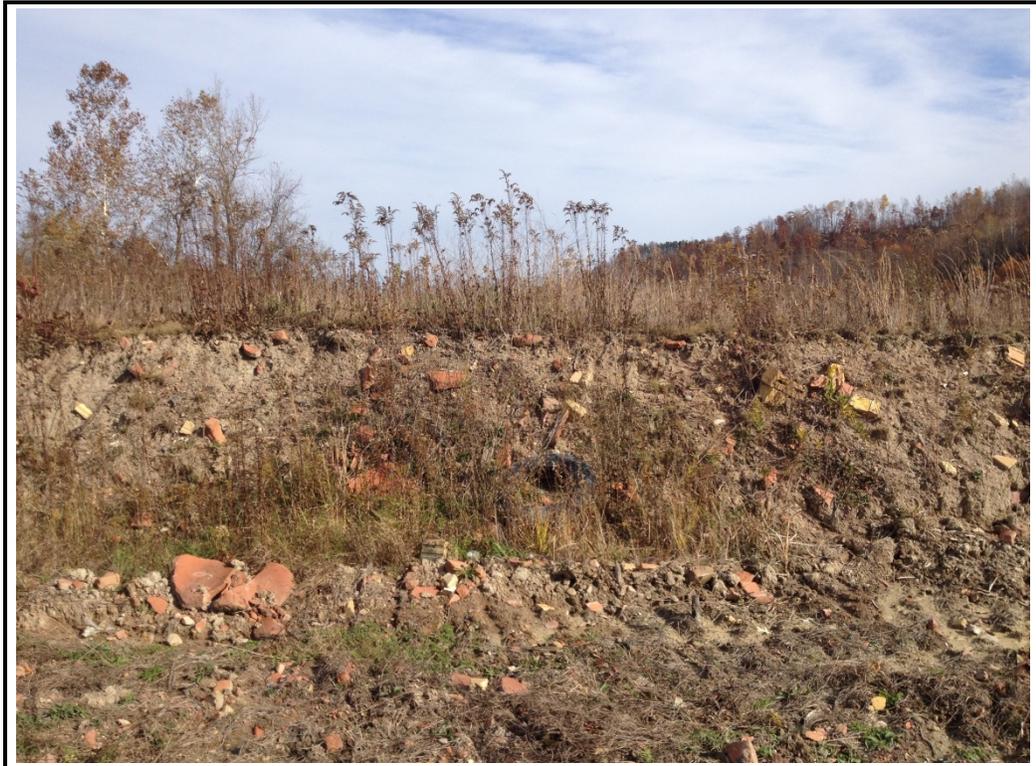
- The sidewalls of the open excavation in the south central portion of the property indicated that as much as eight feet of fill material had been placed across the property. The fill material consisted of a mix of cinders, broken clay sewer tile, coal, sand and gravel. The fill material was considered a REC.

Photograph 3: Sidewall of excavation in the central portion of the Subject Property.
Note broken clay sewer tile

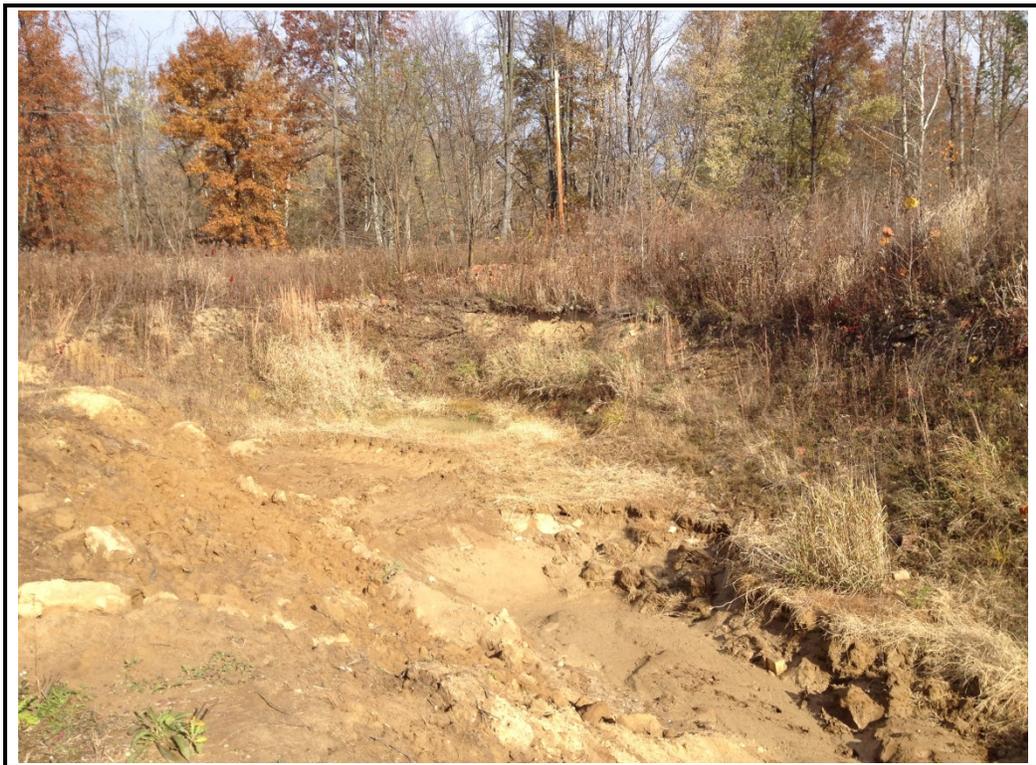
Photograph 4: View into excavation in the central portion of the Subject Property.
Note small amount of standing water in the far end of the excavation

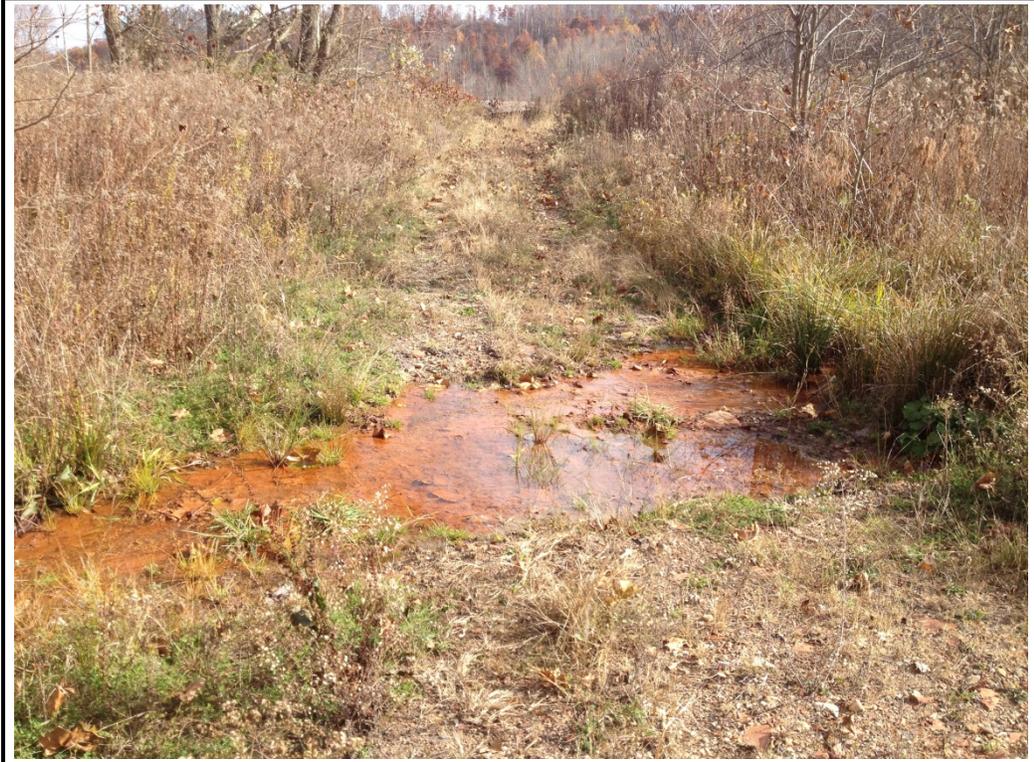
Photograph 9: Drainage swale along the northern property line

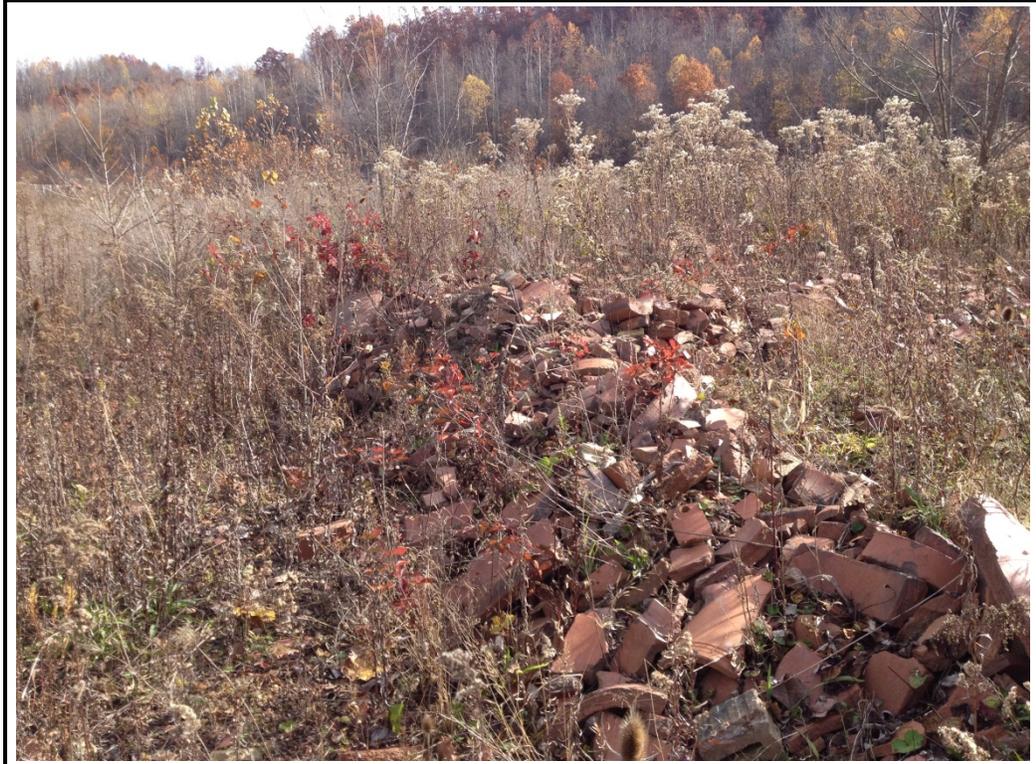
Photograph 11: Rubble pile in the central portion of the Subject Property

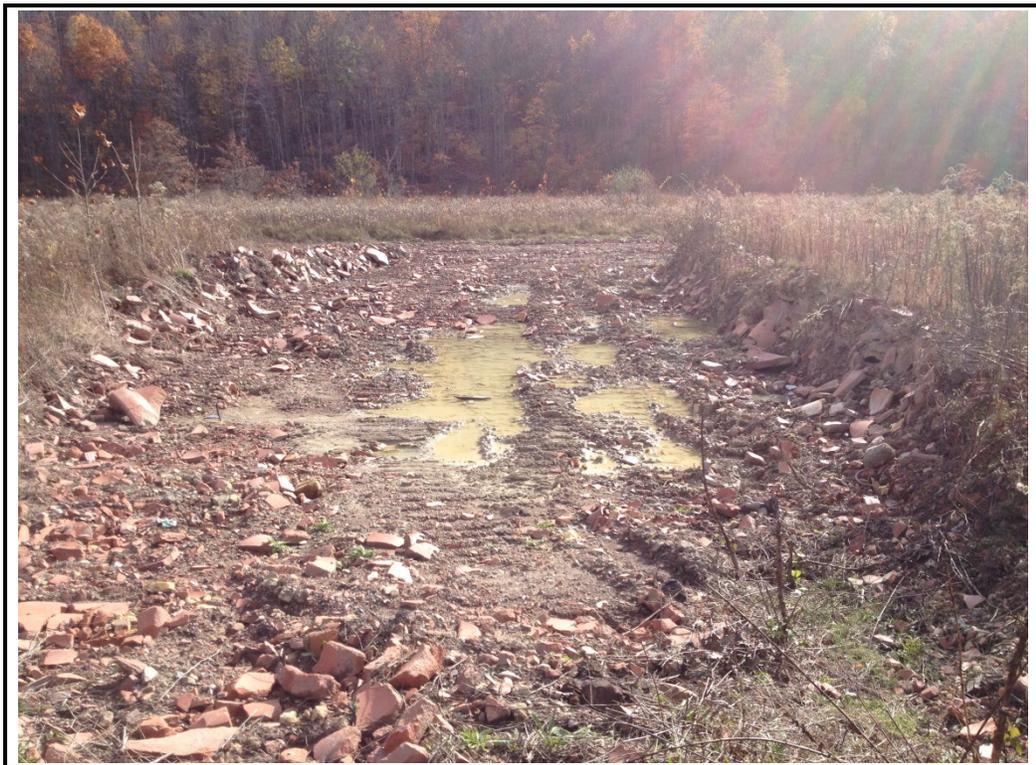
Photograph 12: Clearing in the central portion of the Subject Property. Note broken clay sewer tile

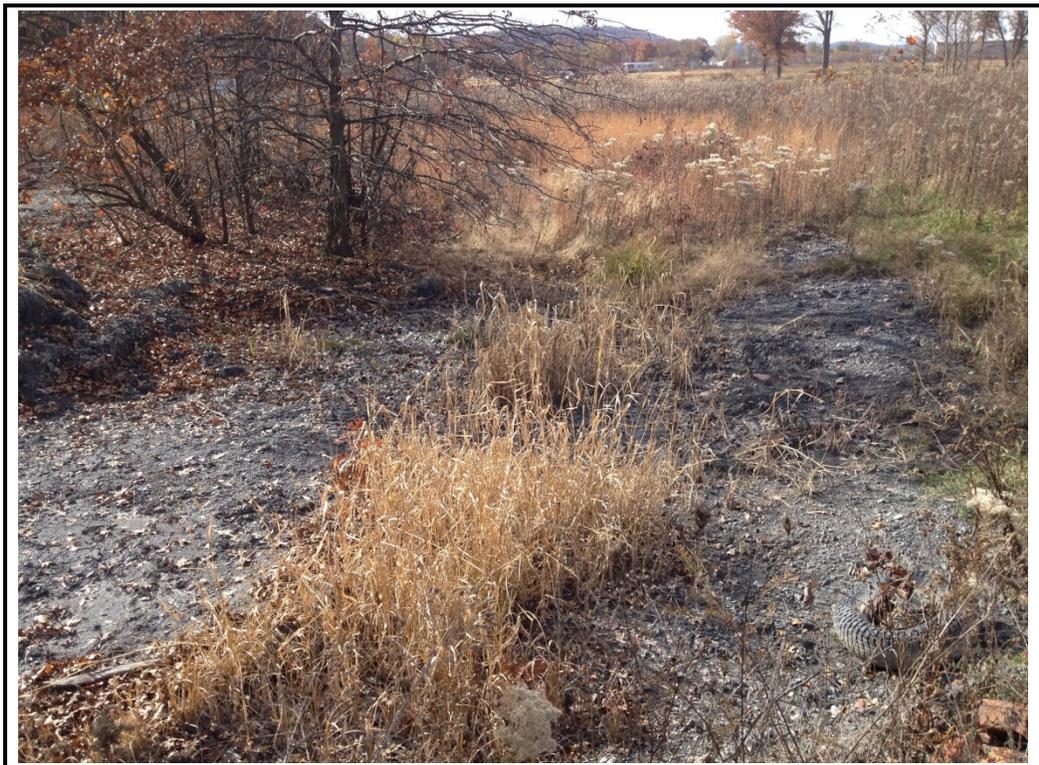
Photograph 14: Gray soil/rock near the oil well

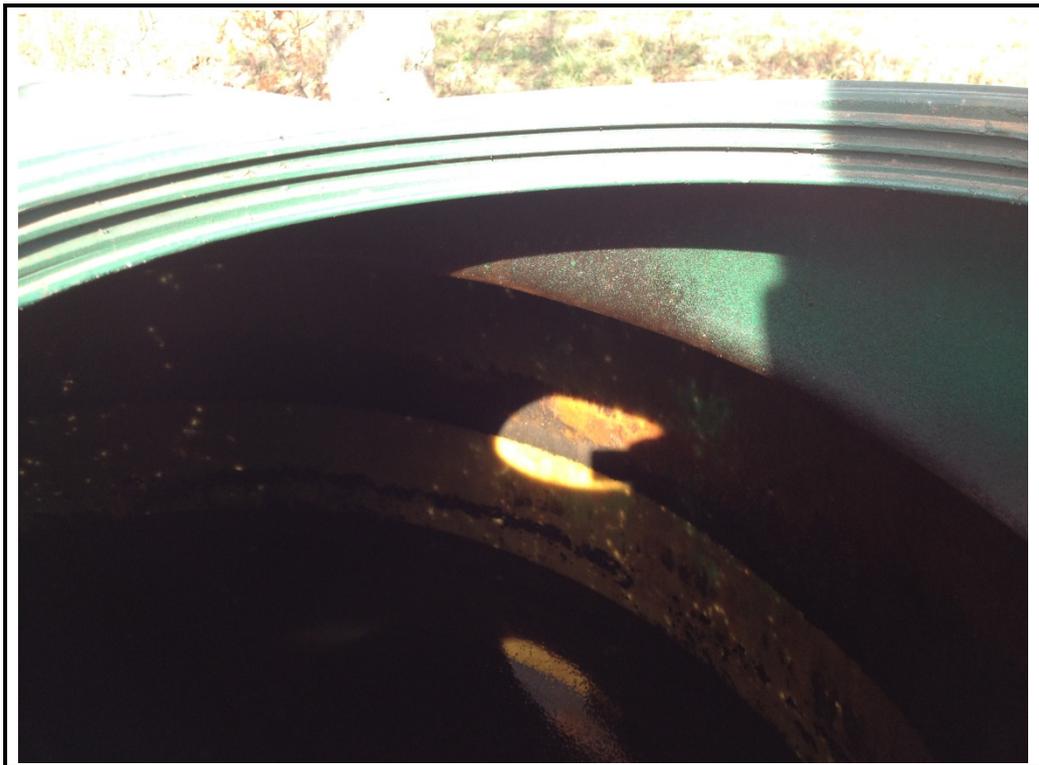
Photograph 16: Oil inside holding tank

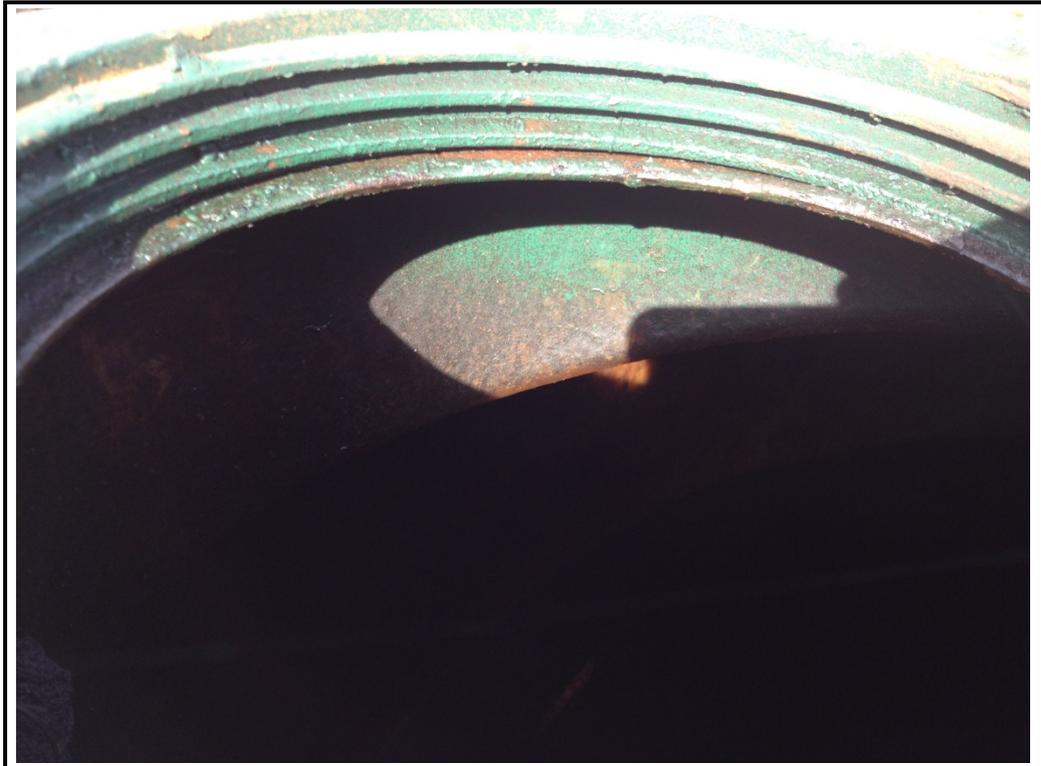
Photograph 17: Oil inside holding tank

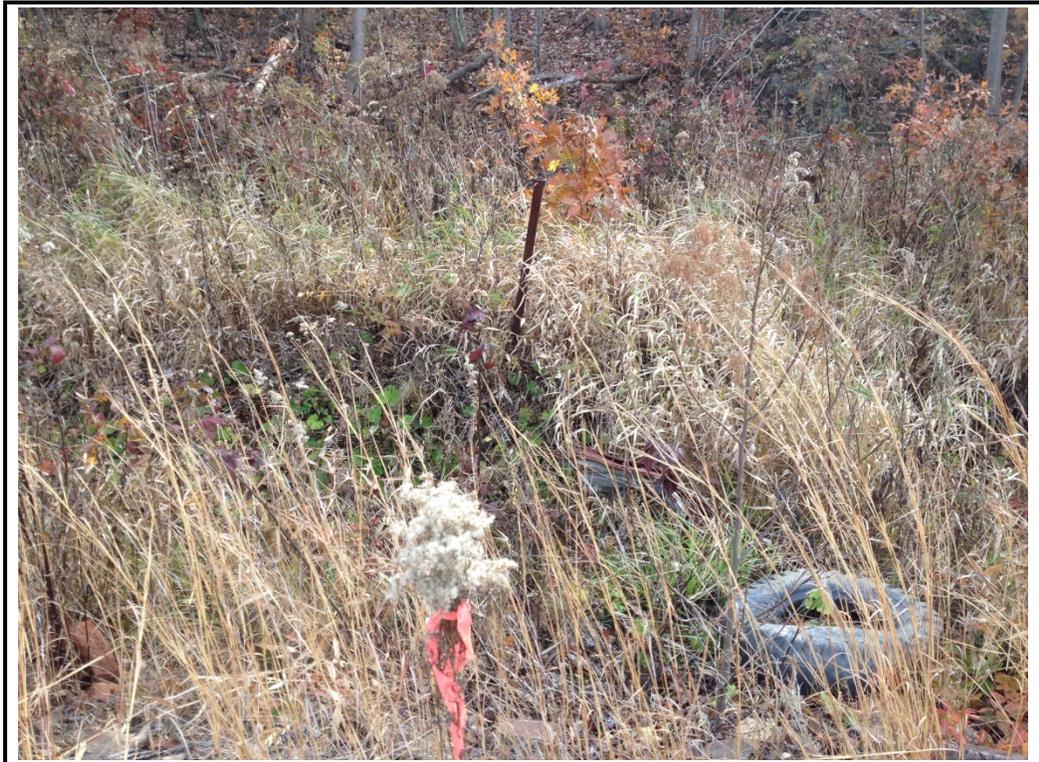
Photograph 20: Northeastern property corner (rusted steel pipe)
